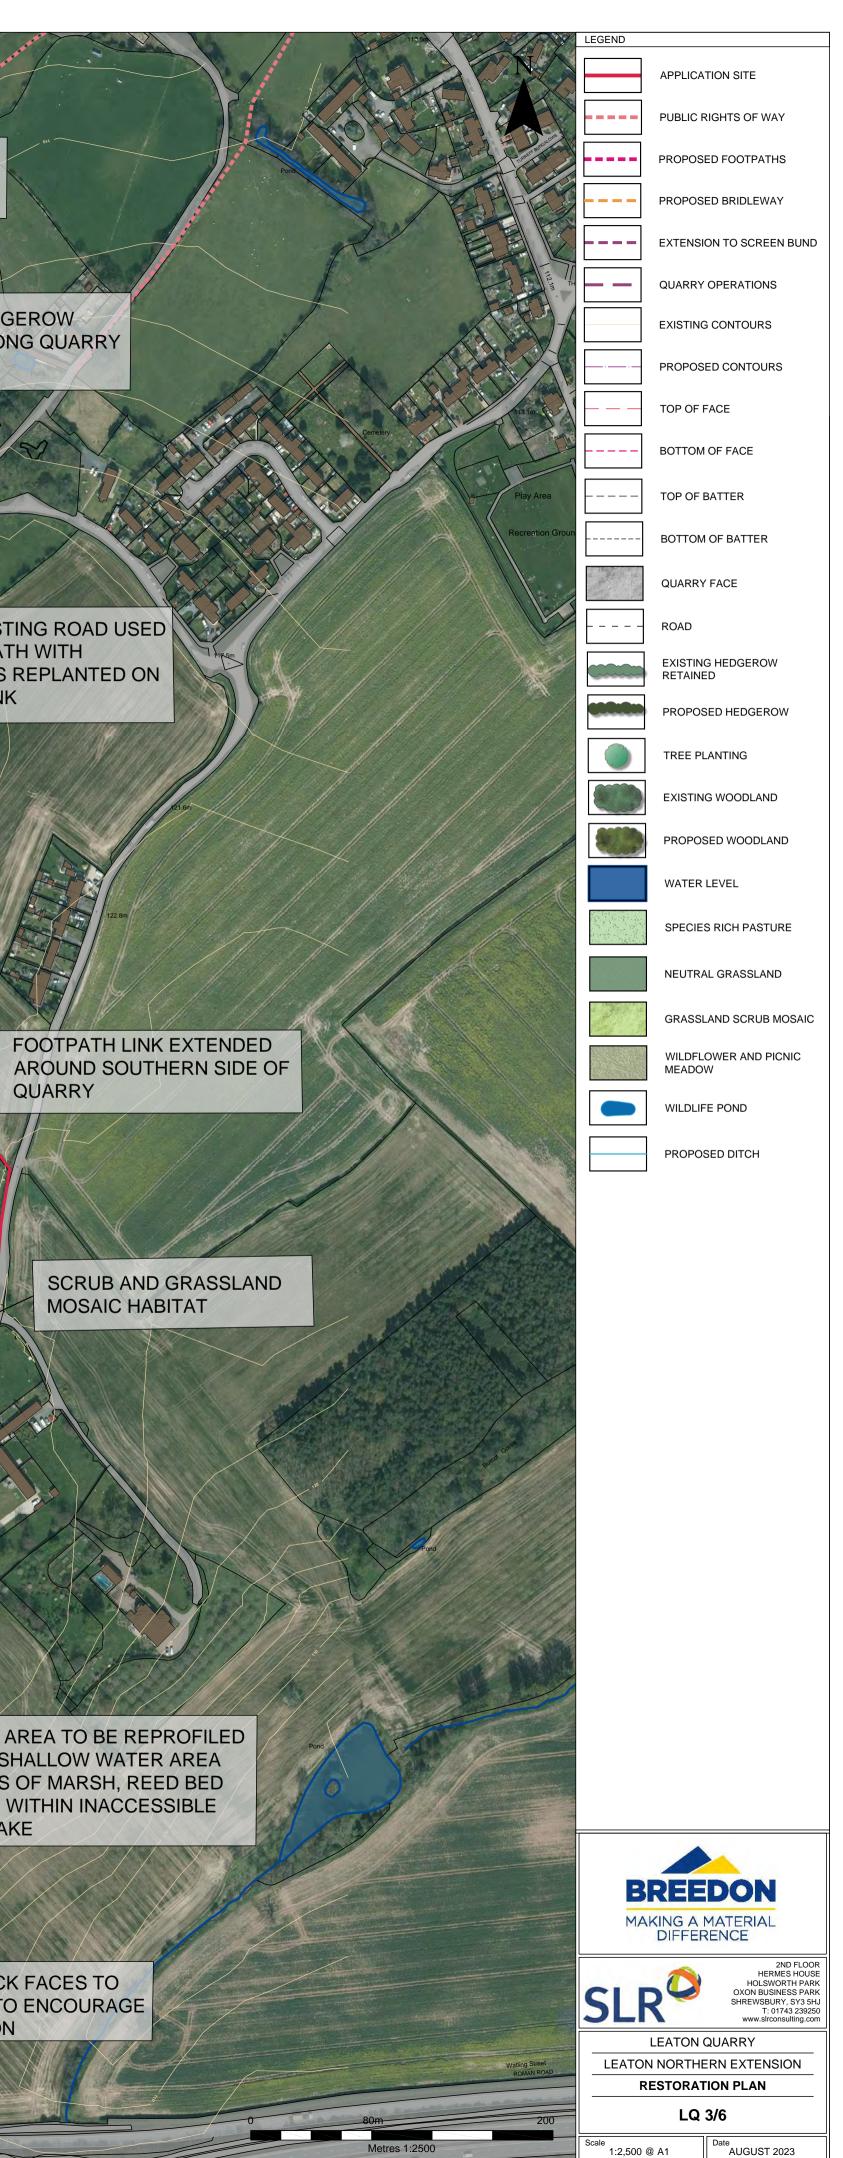
MARGINS OF NEW SETTLEMENT LAGOON PLANTED WITH SCRUB/ WOODLAND HABITAT

PROW DIVERTED AROUND WESTERN SIDE OF QUARRY

NATIVE WOODLAND PLANTING ALONG SCREEN BANK CREST TO FORM BUFFER TO QUARRY WORKING

LAKE OUTFALL BASED ON 85m AOD WATER LEVEL AND CONNECTION TO LEATON BROOK

TOP FACE TO BE BROKEN BACK TO CREATE SLOPE DOWN TO WATER LEVEL

CONTROLLED ACCESS TO LAKE EDGE

WILDFLOWER AND PICNIC MEADOW FOR VILLAGE, SPORT USE AND ORCHARD

WOODLAND PLANTING TO REPLACE PLANTING LOST IN SCREEN BANK REPROFILING

SCREEN BANK RESTORED TO SPECIES RICH PASTURE AND NATIVE WOODLAND

FOOTPATH LINK FROM DIVERTED PROW ALONG SCREEN BANK TO CONNECT TO WROCKWARDINE

EXISTING SCREEN BANK EXTENDED AROUND QUARRY EXTENSION AREA

> **EXISTING HEDGEROW** RETAINED ALONG QUARRY EDGE

LINE OF EXISTING ROAD USED FOR FOOTPATH WITH HEDGEROWS REPLANTED ON SCREEN BANK

> QUARRY TIP AREA TO BE REPROFILED TO CREATE SHALLOW WATER AREA AND ISLANDS OF MARSH, REED BED AND SWAMP WITHIN INACCESSIBLE AREAS OF LAKE

EXPOSED ROCK FACES TO BE TREATED TO ENCOURAGE REVEGETATION
